## CENTRAL INTELLIGENCE AGENCY

SUBJECT Unidentified Soviet Installations  
near Zeitz

DATE DISTR. 25 SEP 1961

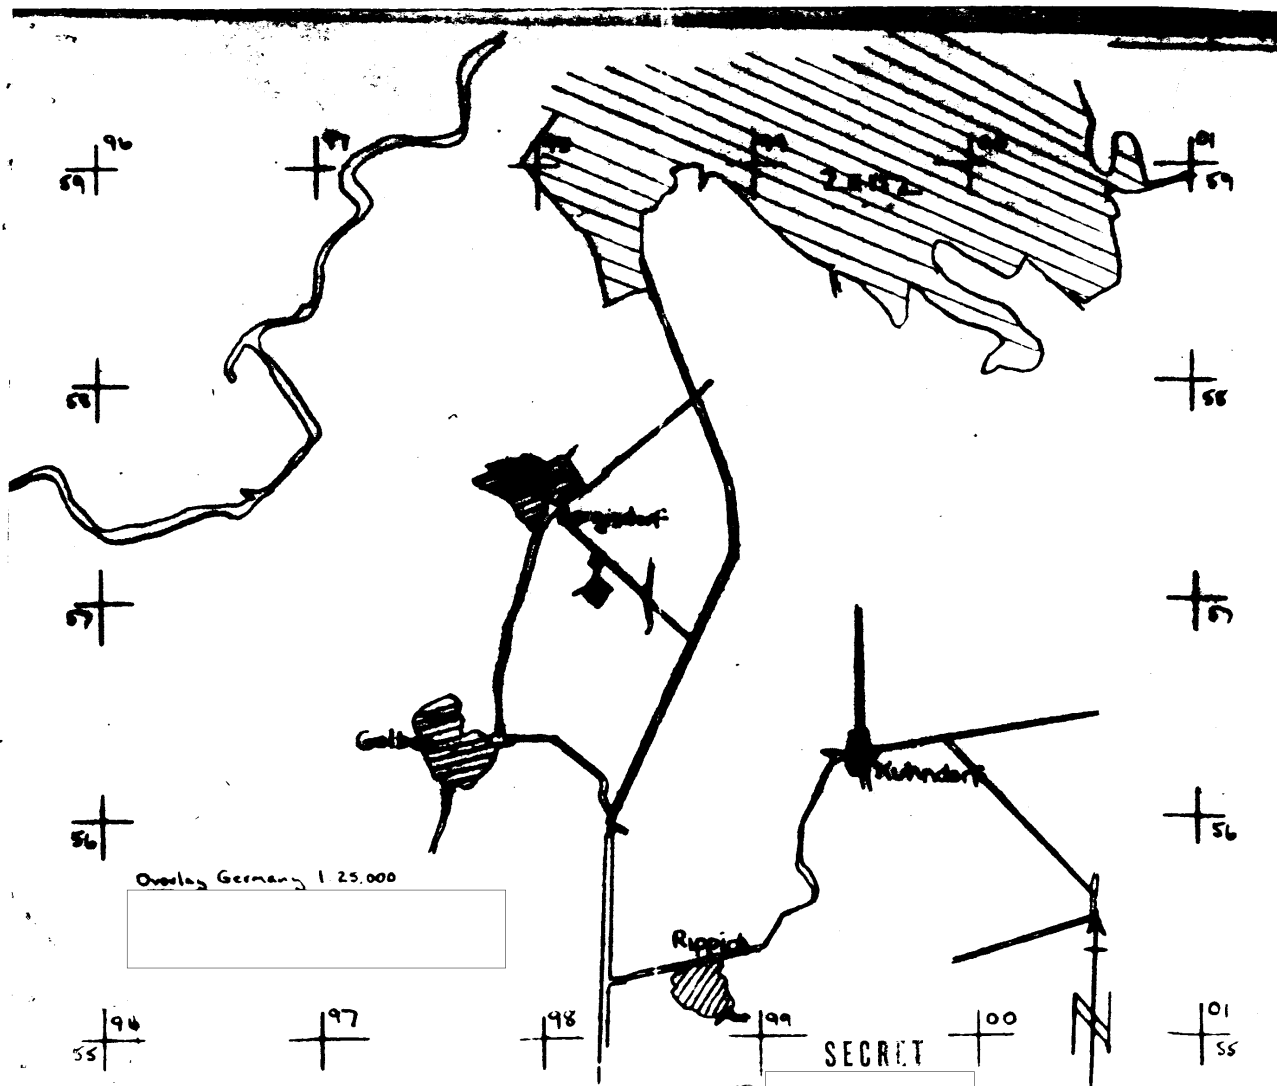
1. Adjoining the southeastern corner of Bergisdorf (approx. 2½ km. south of Zeitz) there was a barbed-wire enclosure approximately 100 m. by 80 m., in the center of which was a heavy metal shed with windows. Along one of the widest sides there were an unknown number of sliding doors occupying the entire face of the building. The shed measured approximately 50 m. by 25 m., with a height of about 5 to 6 m. Near each end of the building, there was a large concrete vent approximately 2 to 2½ m. in diameter with an overhanging gap. Each vent protruded approximately 1 m. above the ground.

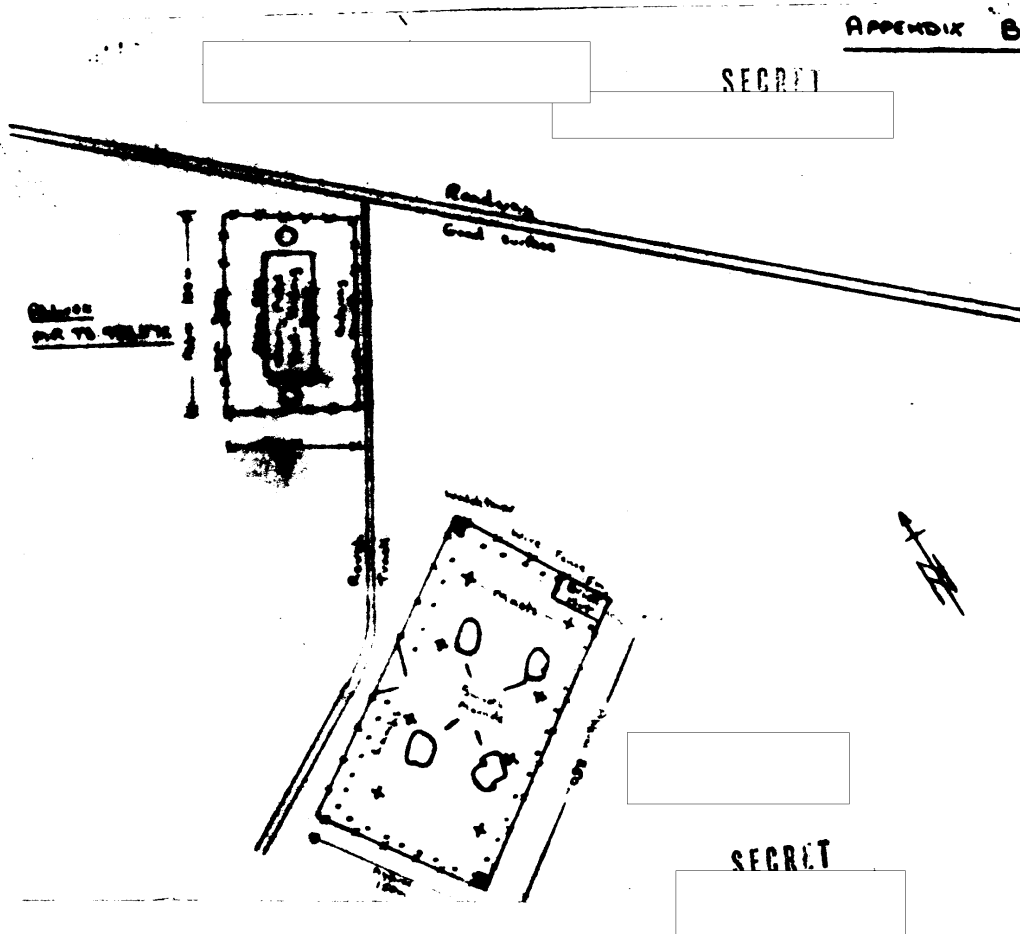
3. [redacted] there was a larger complex enclosed by a barbed-wire fence measuring approximately 250 by 150 m. The fencing was approximately 2 to 2½ m. in height and the inner perimeter was covered by a continuous row of large electric lamps. Two wooden watchtowers were located at opposite corners of the site. Within the enclosure, there were four shallow mounds covered by earth which protruded approximately 1½ to 2 m. above the surface.

There were eight masts, each approximately 15 m. in height, which were surmounted by a lightning conductor. Apart from the wire securing guys, there was no obvious aerial arrays between the masts. A small brick building measuring approximately 15 by 10 m. with windows on one side was located in one corner near the perimeter fencing. On 23 July 1961, the watchtowers were manned and sentries were seen patrolling near the outside of the installation. A rough track leading down from the nearby roadway connected both of the sides.

showing the locations of the two installations.
2. A rough sketch, not to scale, showing the layout of both installations.
